Barn at 332 West Street, Amherst MA

Conditions Assessment and Scope of Work Report

January 2014

Gusakov Woodworks
www.gusakovwoodworks.com
willgusakov@gmavt.net
802-318-8664

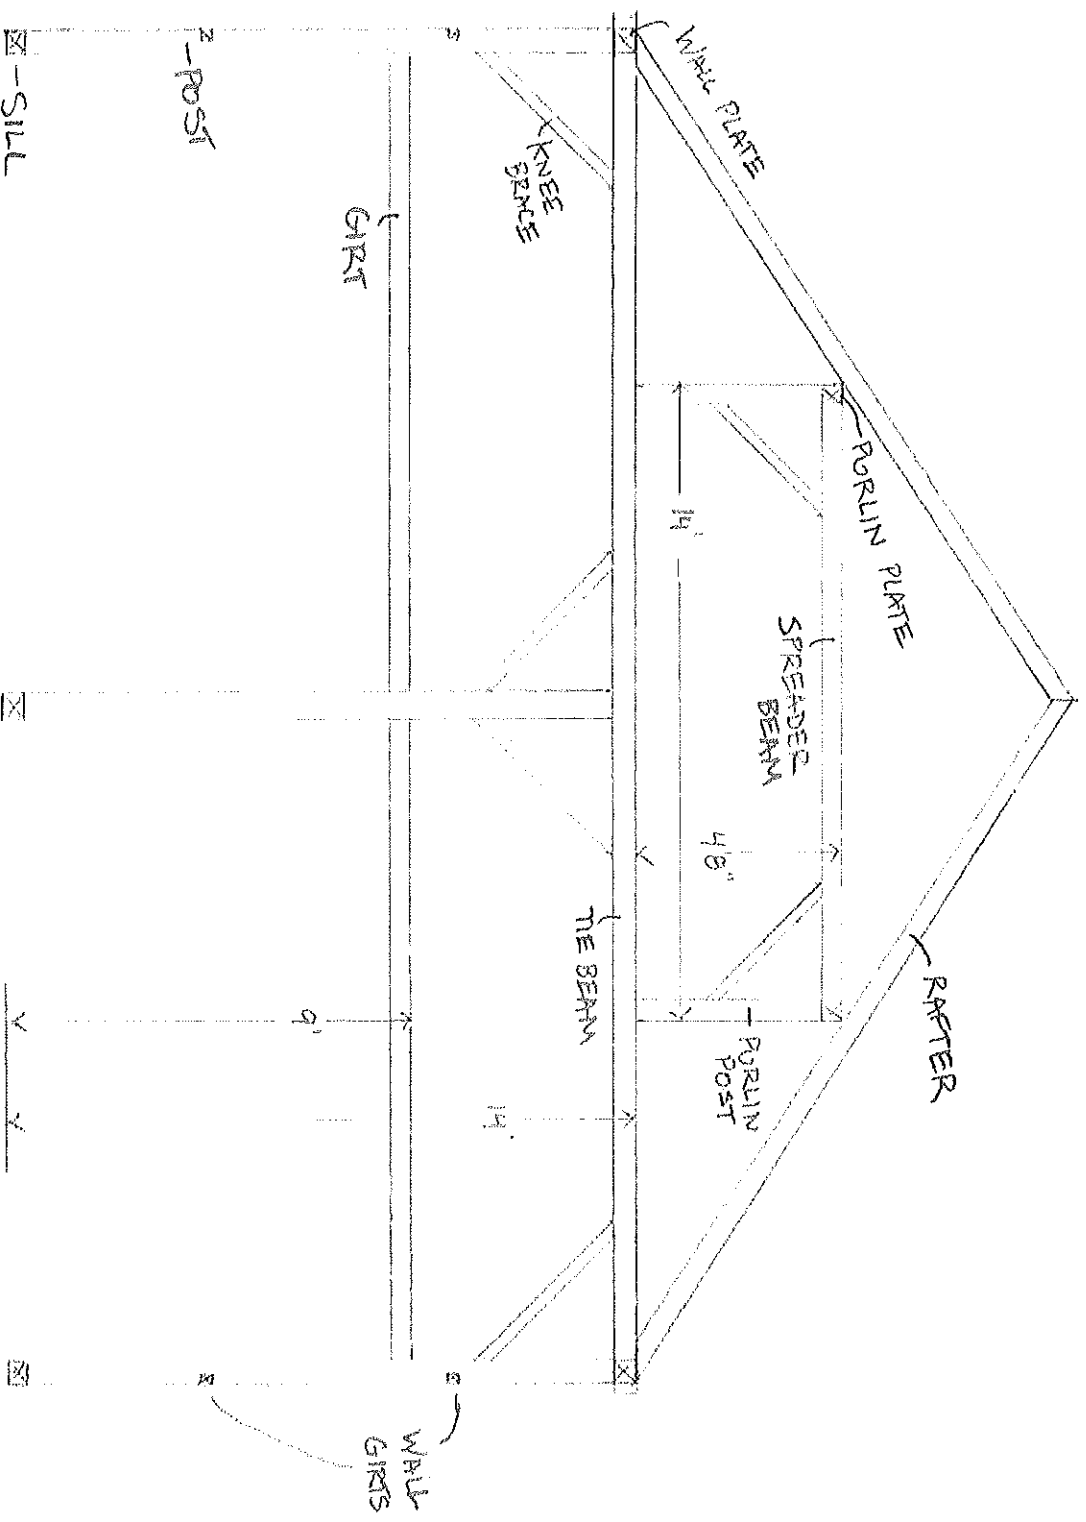
TYPICAL BENT FRAMING / BARN AT 332 WEST ST / 1 1/4" = 1' / GOSAIKON WOODWORKS

The original barn structure is a square-ruled, late-era timber frame measuring 30'2" x 60'1". The frame features 5 bents, spaced at even 15' increments. Each bent has one center post, creating a two-aisled, four-bayed floor layout (please see attached drawings detailing floor plan and framing). The barn originally featured access to the two aisles through 2 pairs of large hung doors on the road (West) side, as well as two pairs of large hung doors on both the North and South sides of bay 4 (the farthest from the road). The barn was originally founded on field-stone piers, and clad in vertical pine boards and (interior) battens. The roof was skip-sheathed with pine slabs, and covered with wooden shingles.
